Trawler sinking tests at

Recent losses of small beam trawlers have prompted questions regarding their behaviour during capsize, sinking and settling on the sea bed.

The Marine Accident Investigation Branch of the Department of Transport sought to determine whether the attitude and condition of a vessel on the sea bed could provide any clues to the way in which it sank. To this end they commissioned the Wolfson Unit at the University of Southampton to conduct a series of tests, sinking a model trawler in a variety of ways and filming its behaviour throughout. Barry Deakin of the Wolfson Unit reports on the tests and conclusions.

the Wolfson Unit

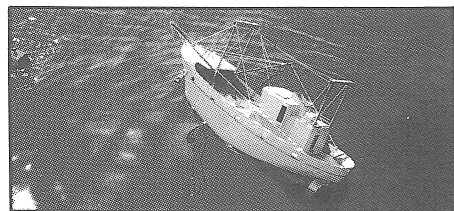
A. Starboard gear snagged on the bottom, port gear (represented by a weight) raised to bulwark height with the port derrick lowered. Tension being increased in the trawl warp.

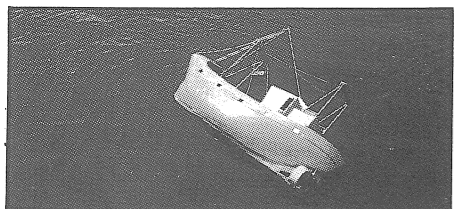
Model hauled over to immerse the engine room hatch and fish hold hatch. The port gear and derrick have swung across to starboard.

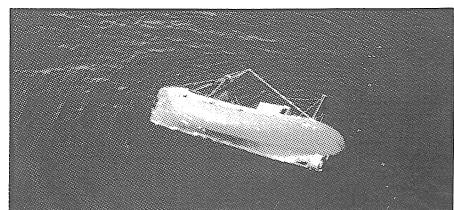
Model stable at 90 degrees and flooding rapidly.

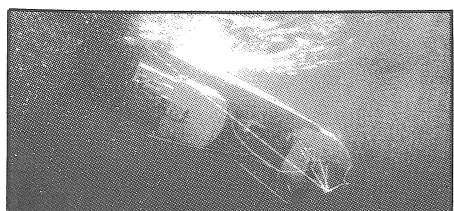
Model now heeled to approximately 134 degrees with only the stern above water. Flooding slowly.

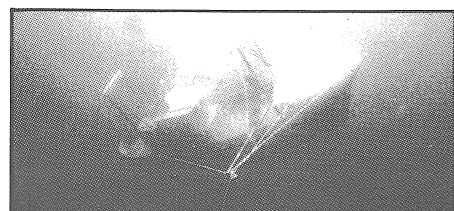
Sinking to the bottom, righting and venting air.

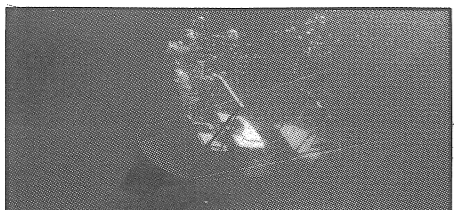
Striking the sea bed with the starboard bilge and still venting air.

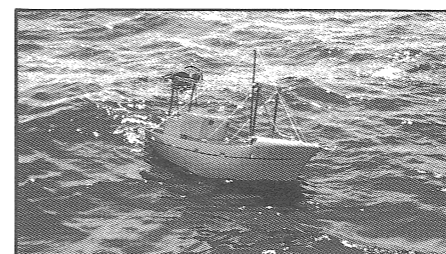
B. Port gear snagged on the bottom, starboard gear on deck, starboard derrick raised. Tension being taken up on the trawl warp.

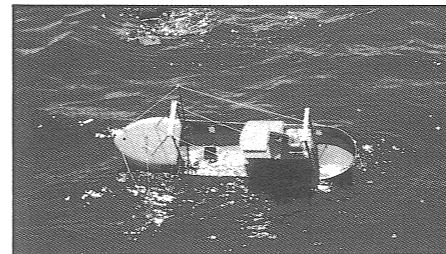
Model hauled over to immerse the net store hatch (under the whaleback), and intermittent flooding through the deckhouse door.

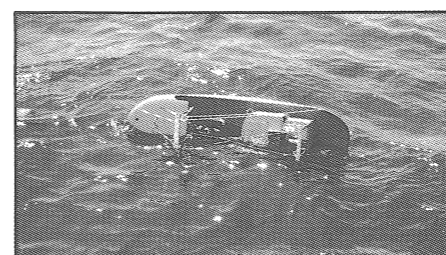
Flooding increased with the fish hold hatch and wheelhouse window submerged.

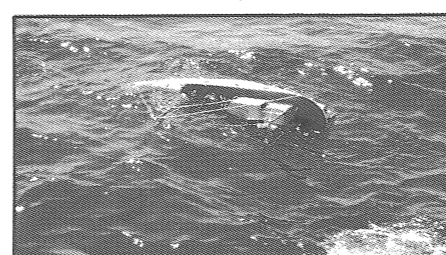
The rate of flooding reduces as the hatches become totally submerged.

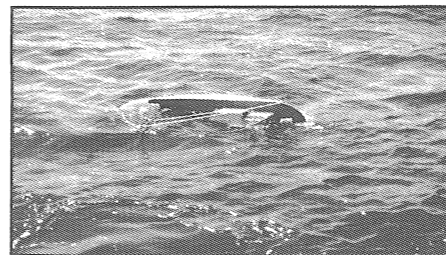
Model stable at 90 degrees and flooding slowly.

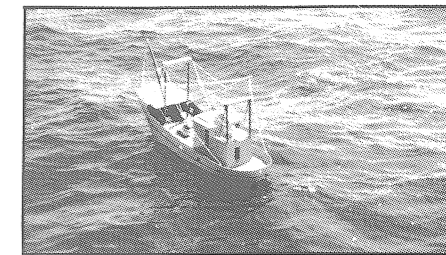
C. Starboard gear snagged on the bottom, port gear on deck, port derrick raised. Model prepared for testing, tension being taken up on the trawl warp.

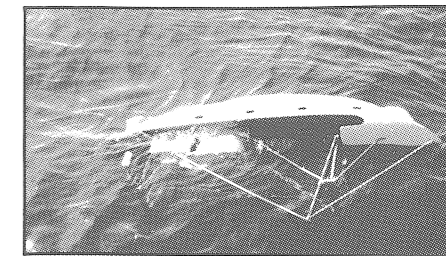
Model flooding fast, venting the aft compartments through the deckhouse openings.

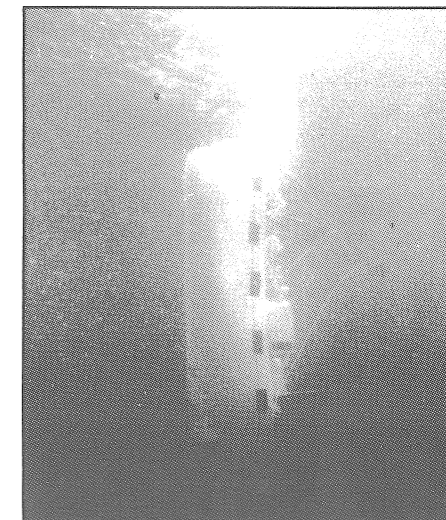
Model descending stern first and accelerating, venting fast through the wheelhouse windows.

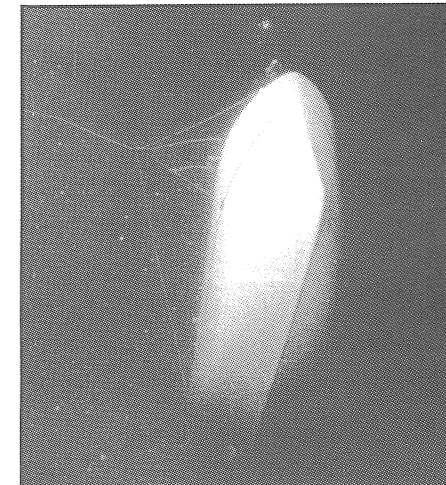
Model striking the bottom with the rudder.
